Turbo Generator Rotor Removal

Quartzelec design and manufacture a generator framework and rail system within the turbine enclosure, to facilitate the rotor extraction and retaining ring removal for a 2-Pole, 79,375kVA, 10.5kV, 3000RPM Twin pack Turbo Generator as part of a Major Inspection.

ENEL | POWER GENERATION | MAHON, SPAIN

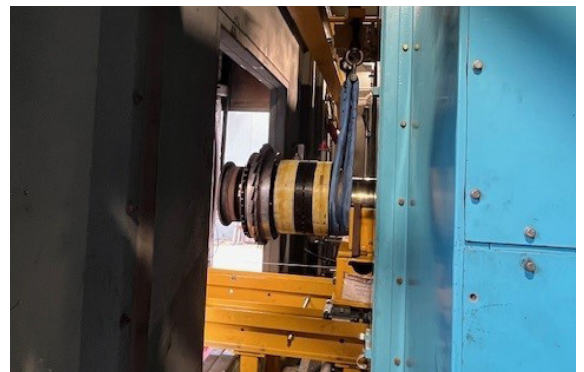
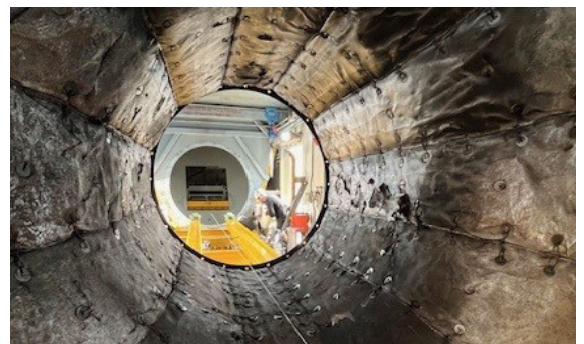
Precise measurements were taken, ensuring the rail system was custom-fit for the enclosure and given the absence of cranes within the turbine enclosure, specialised trolleys were designed to support the rotor throughout the extraction and retaining ring removal process. Additionally, a framework was constructed around the generator to facilitate the disassembly.

Once the rotor and retaining rings were successfully removed, both the stator and rotor underwent thorough cleaning, including the use of cryogenic cleaning techniques to safely eliminate contaminants without damaging components. Minor repairs were carried out as needed, and the generator was carefully reassembled to ensure reliable operation. A comprehensive suite of electrical tests was performed on both the stator and rotor, including Partial Discharge (PD), Tan Delta, EL-CID, and End Winding Bump Tests, to verify the condition and performance of the generator.
